MERRIMACK RIVER BASIN  
NASHUA, NEW HAMPSHIRE

SUPPLY POND DAM

NH 00123

PHASE I INSPECTION REPORT  
NATIONAL DAM INSPECTION PROGRAM

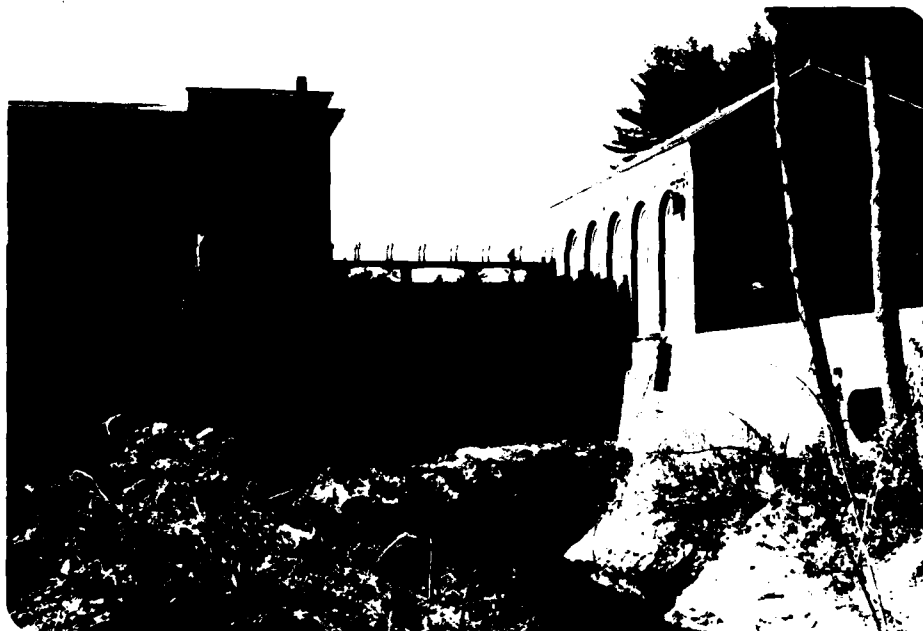
Overview of spillway from downstream channel

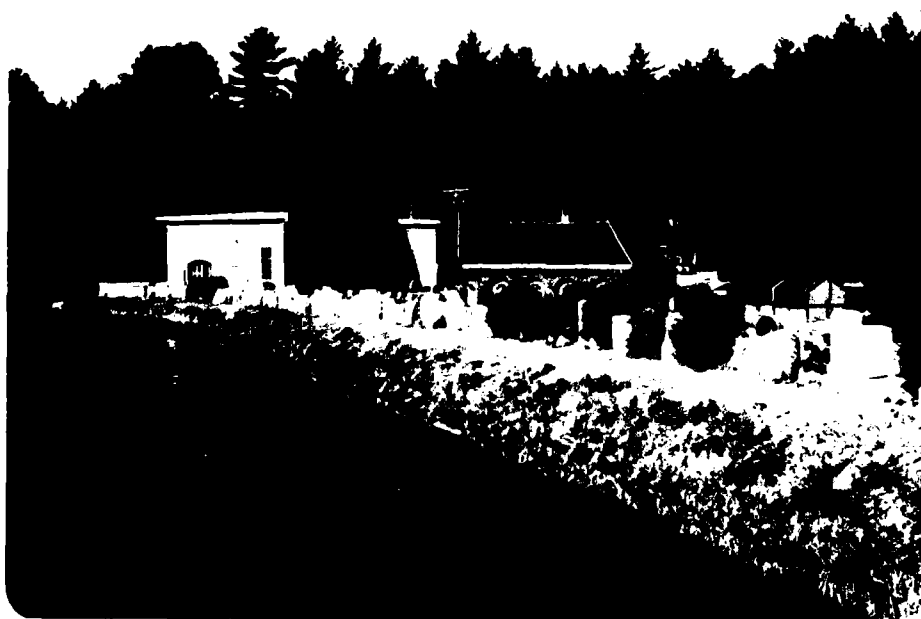
Overview of dam from right abutment upstream

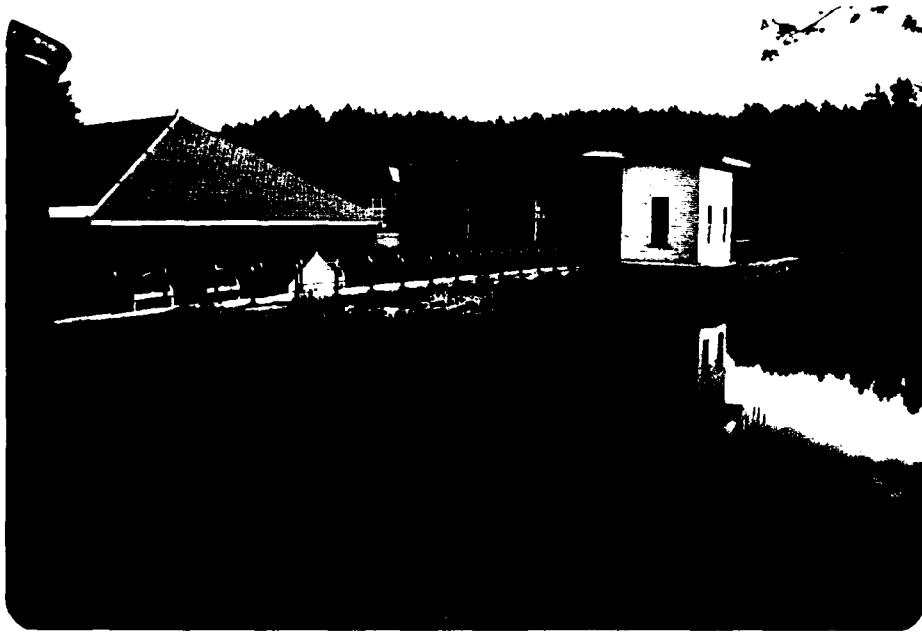
Overview of dam from left upstream side

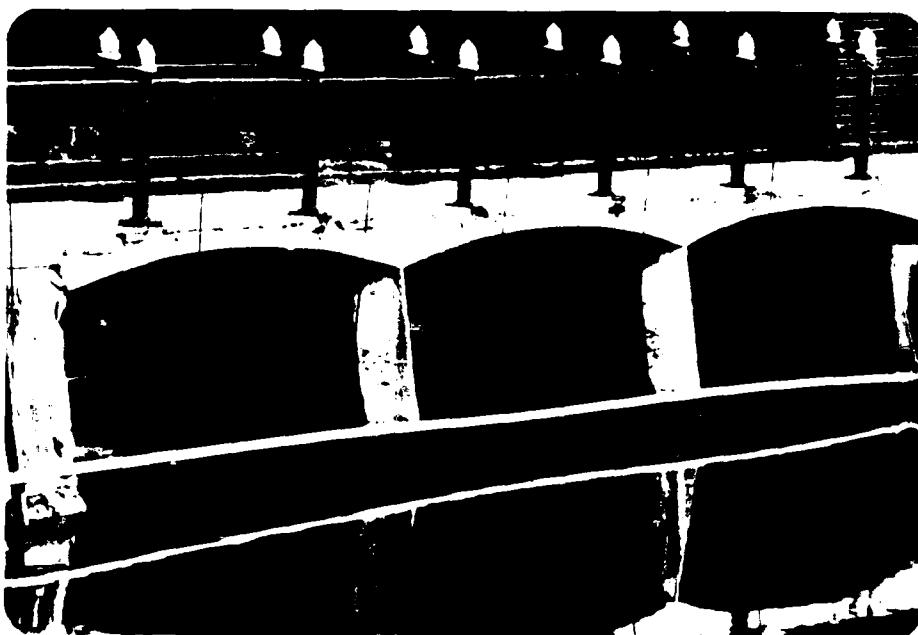
The three span service bridge structure deck exhibits minor surface spalling and a transverse crack. The spalling can be attributed to excessive surface trowelling of concrete and the random cracks can be attributed to expansion of the concrete deck. There is also considerable random surface cracking and efflorescence on the underside and at the fascias of this service bridge.

4. View of concrete deterioration on spillway  
piers and service bridge
